# N2NA Pylon Overheat Mishap

Bart Henwood  
Board Chairperson  
1 Dec 07

- \$605K in damage to fuselage structure and pylon panels
- Proximate Causes –
  - Precooler coupling installed without retaining ring allowed 400 deg F/40 psi air to damage structure and disable primary warning system (SPF)
  - Wiring to the pylon hot warning system temperature sensor broke, disabling the system and preventing the primary aircrew warning of the bleed air leak condition.
- Root Causes – None
  - Did not uncover any systemic organizational factors

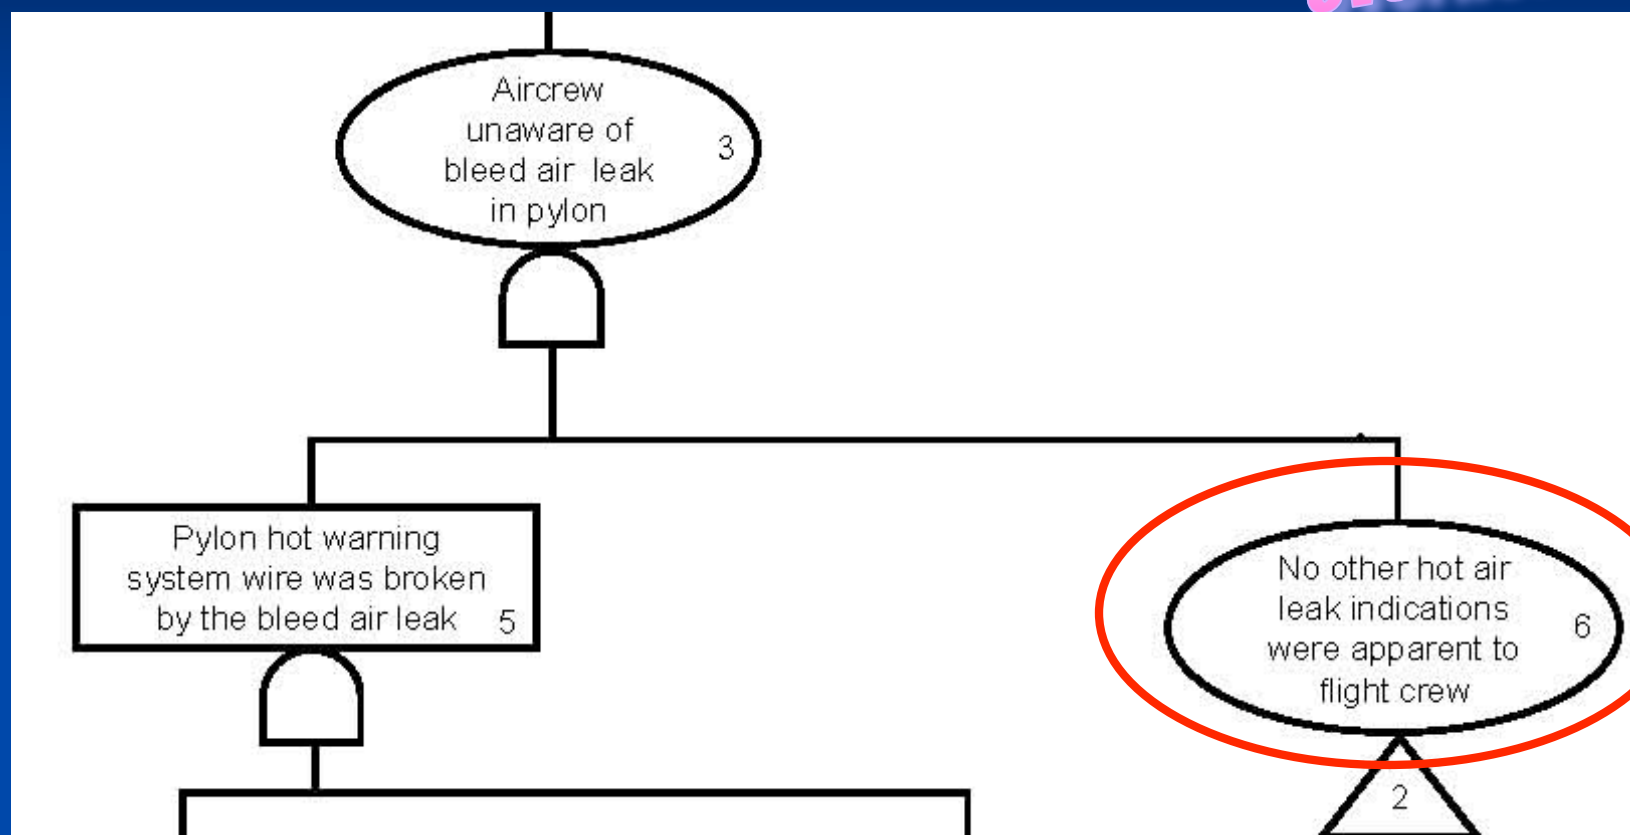
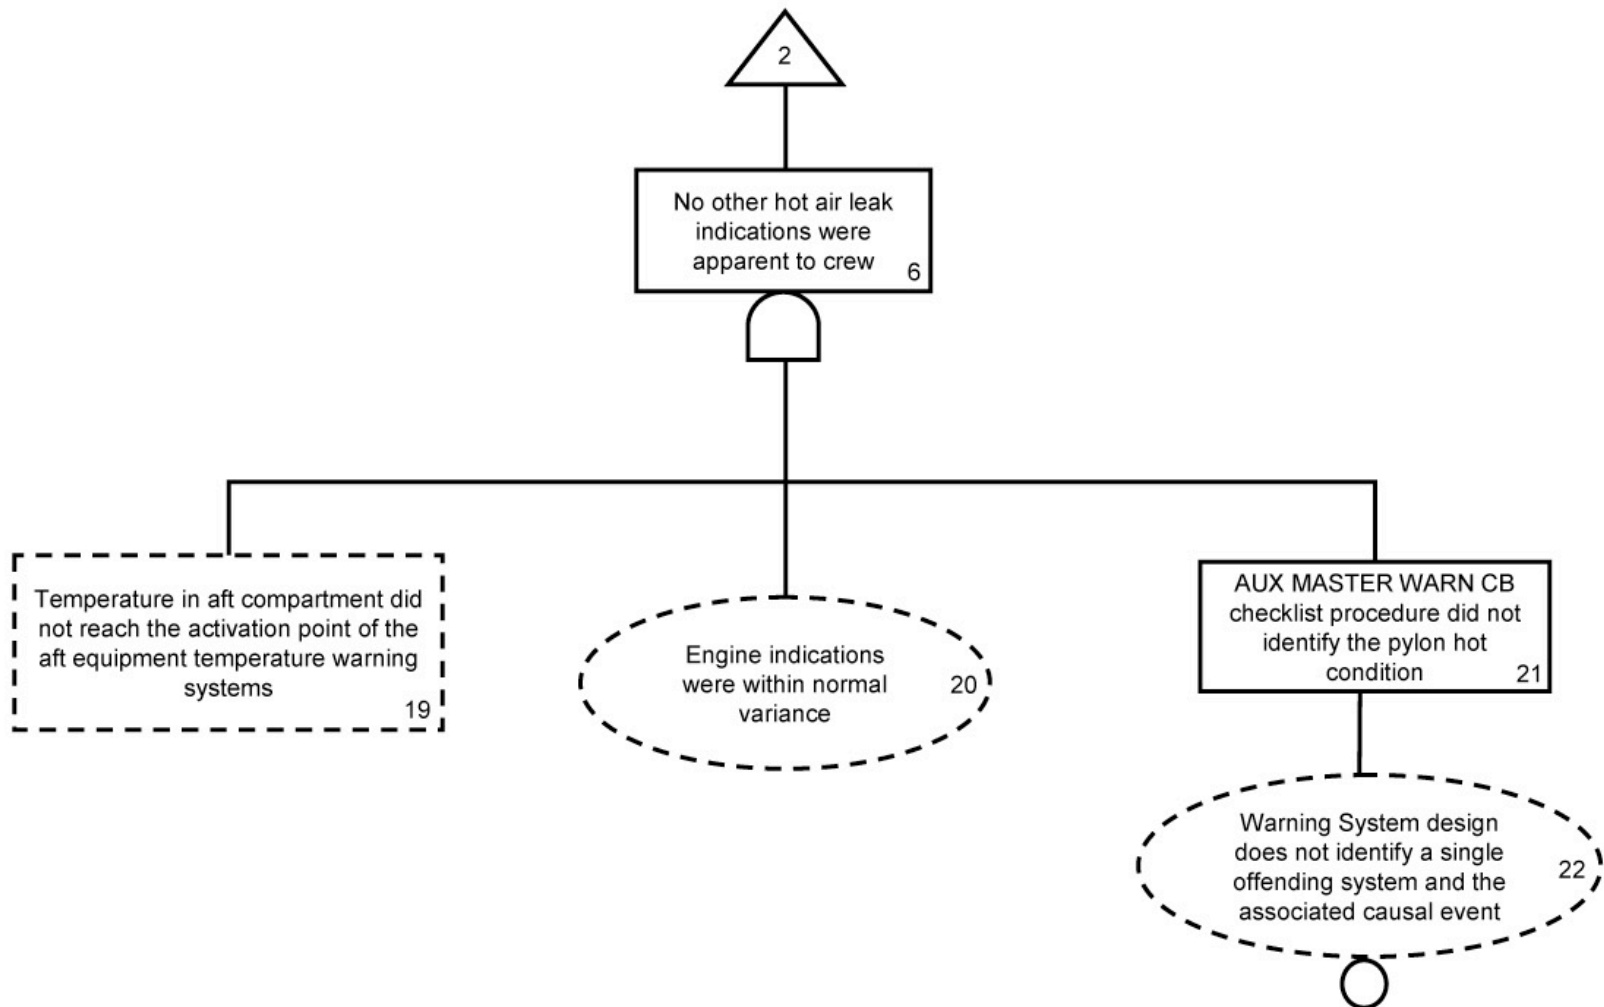
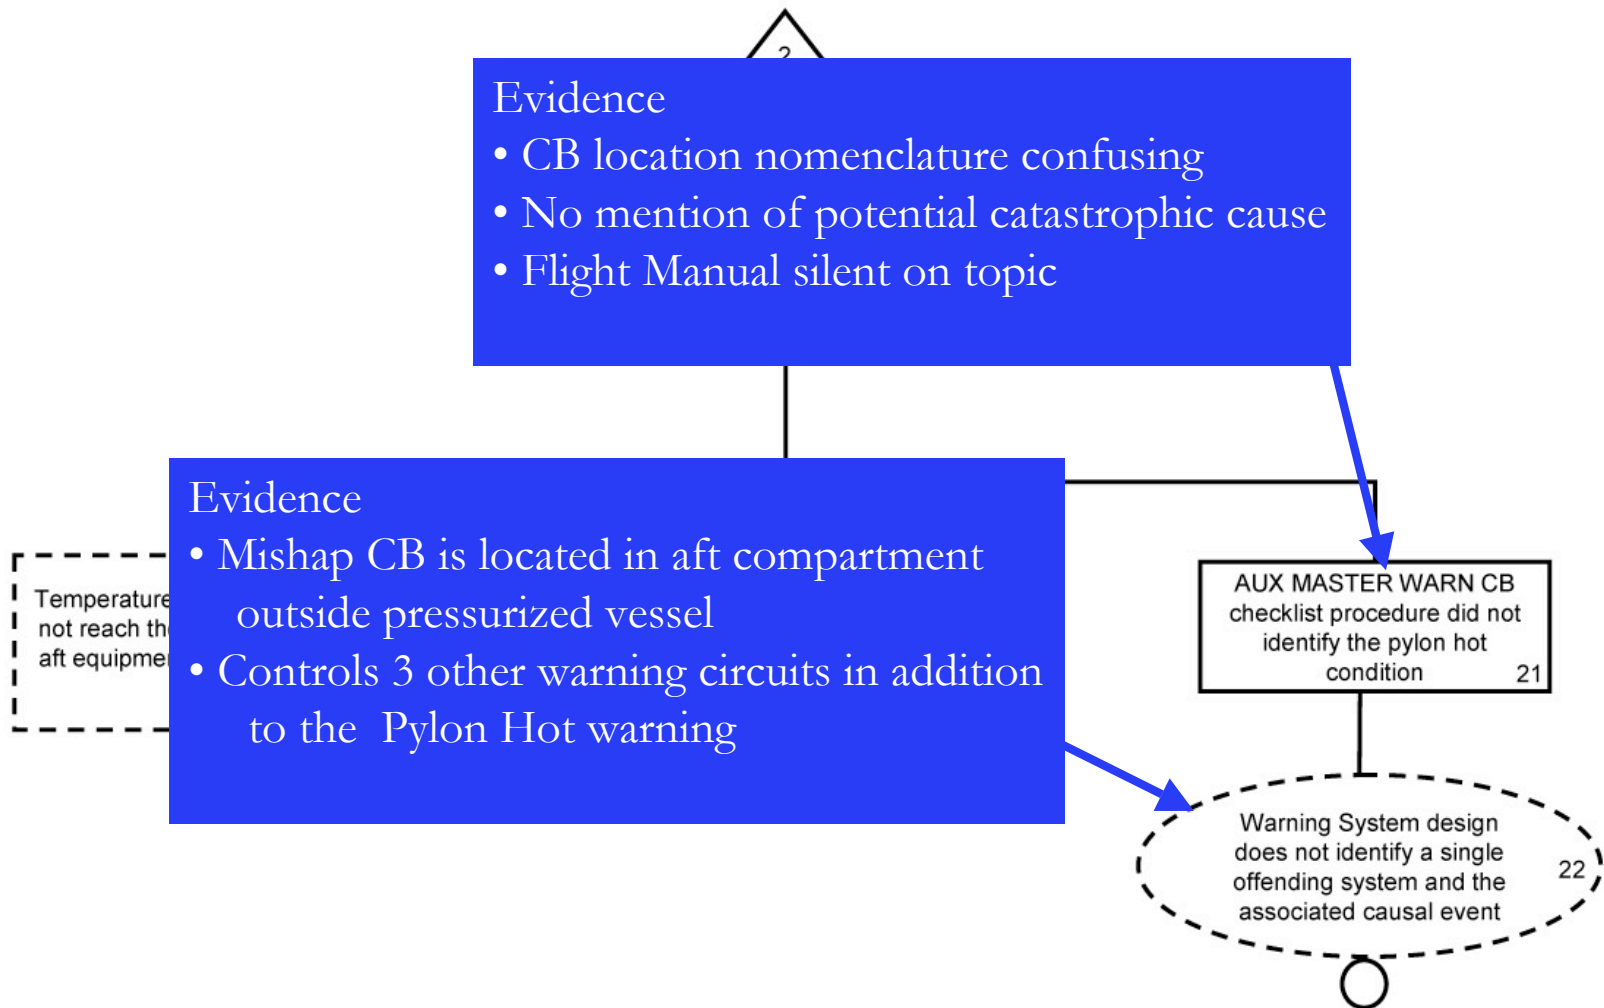
## No Other Indications of Leak

AUX MASTER WARN CB checklist procedure did not identify the pylon hot condition 21

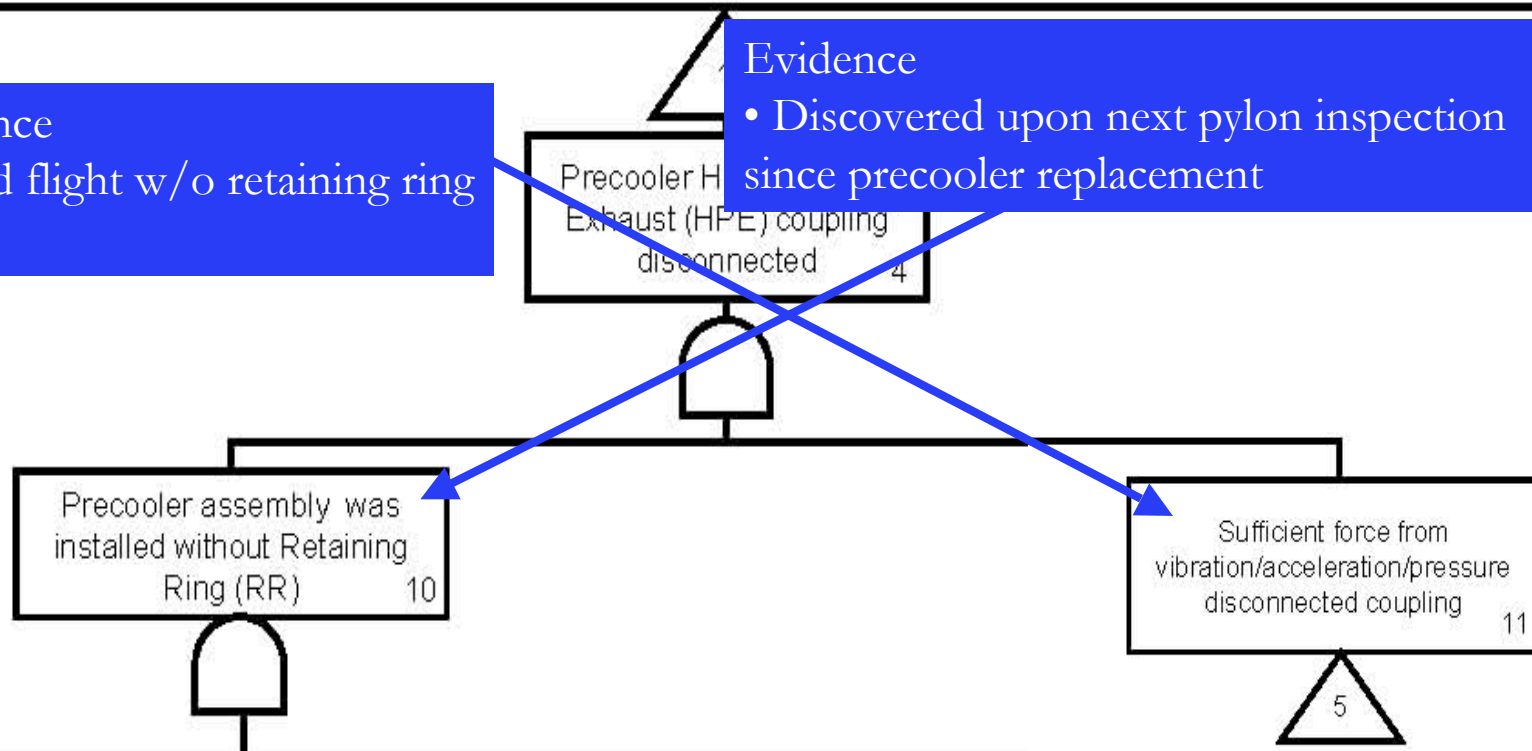
## HPE Coupling Disconnects

- Discovered upon next pylon inspection since precooling replacement

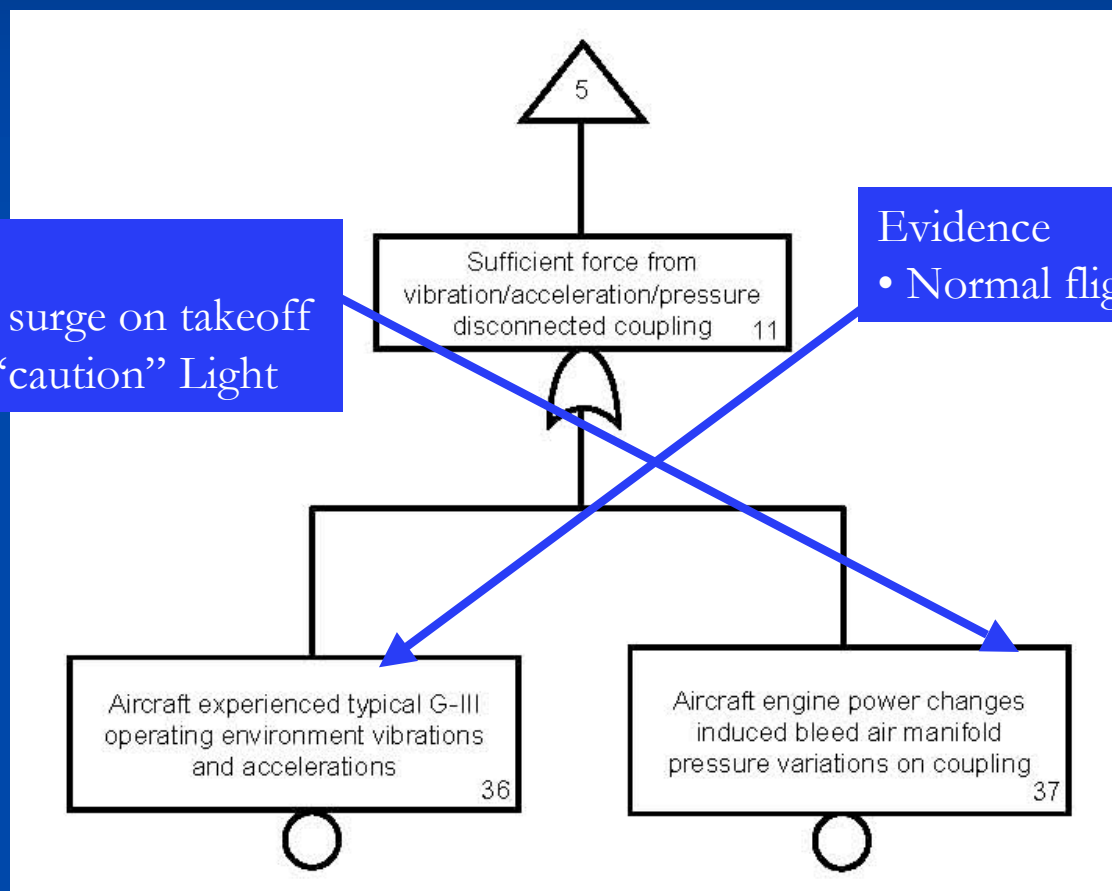
## Sufficient Force/Vibration

- Initial engine surge on takeoff aligned with “caution” Light

- Normal flight envelope (FDR)

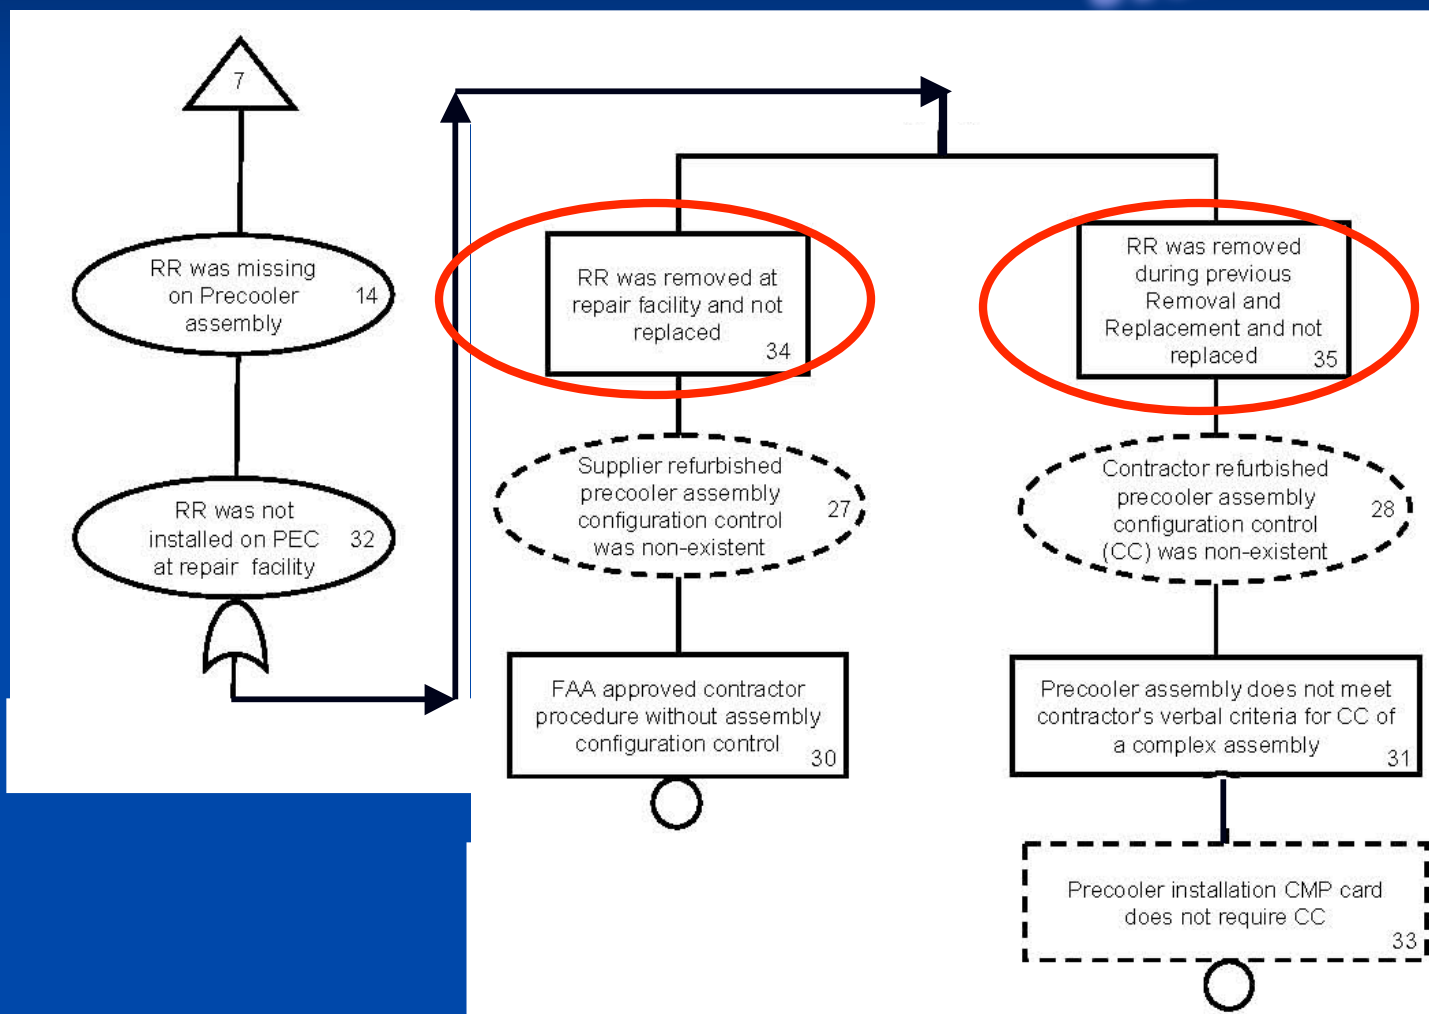
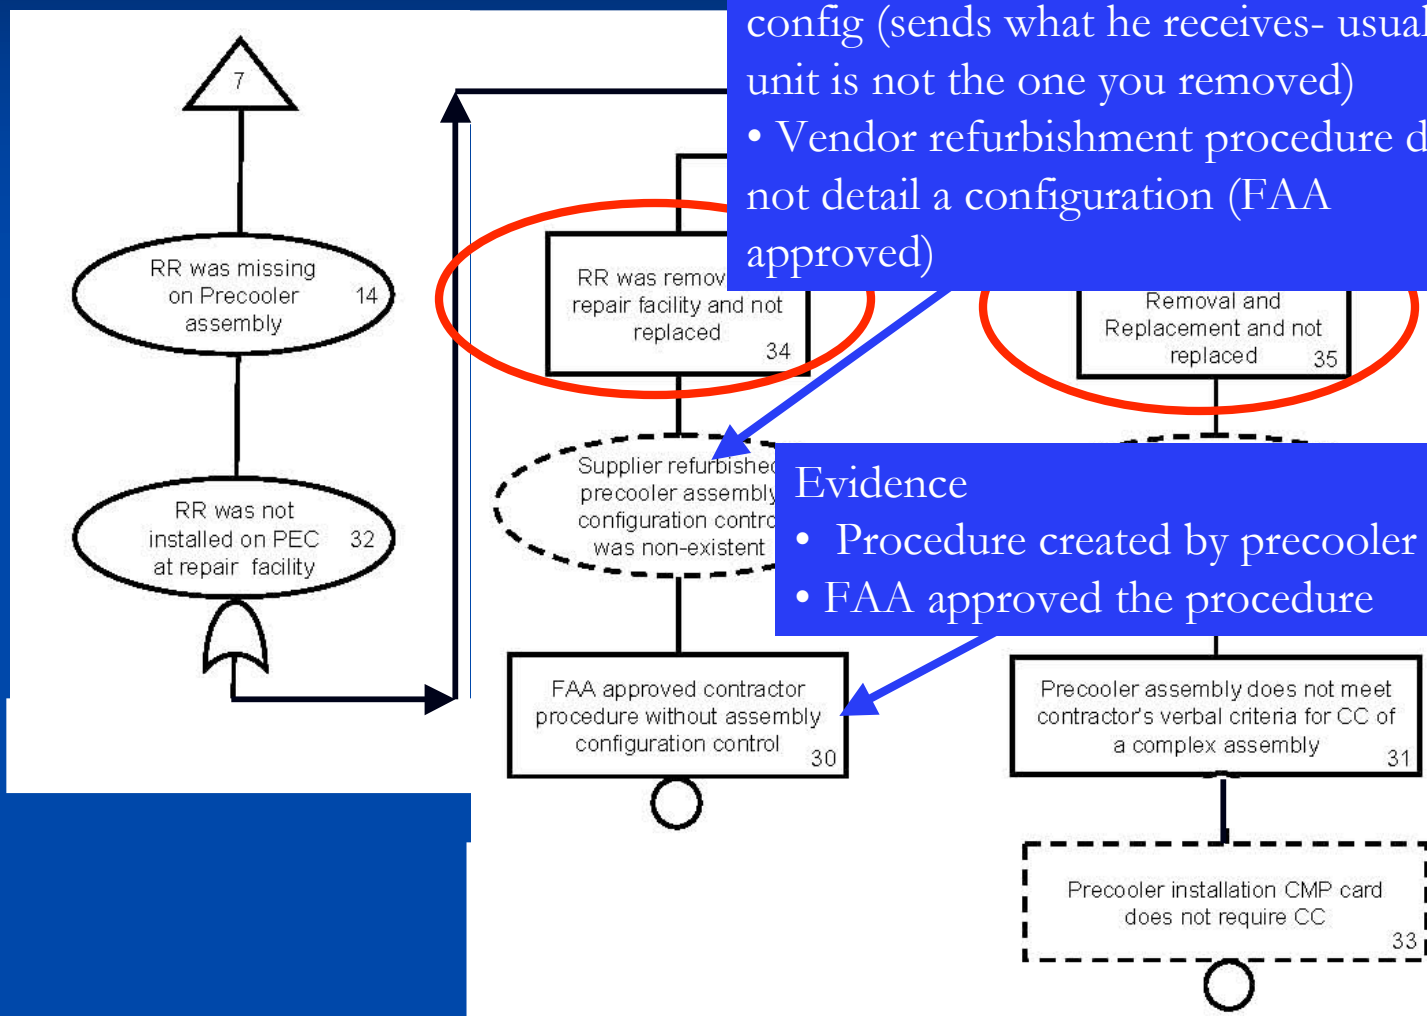
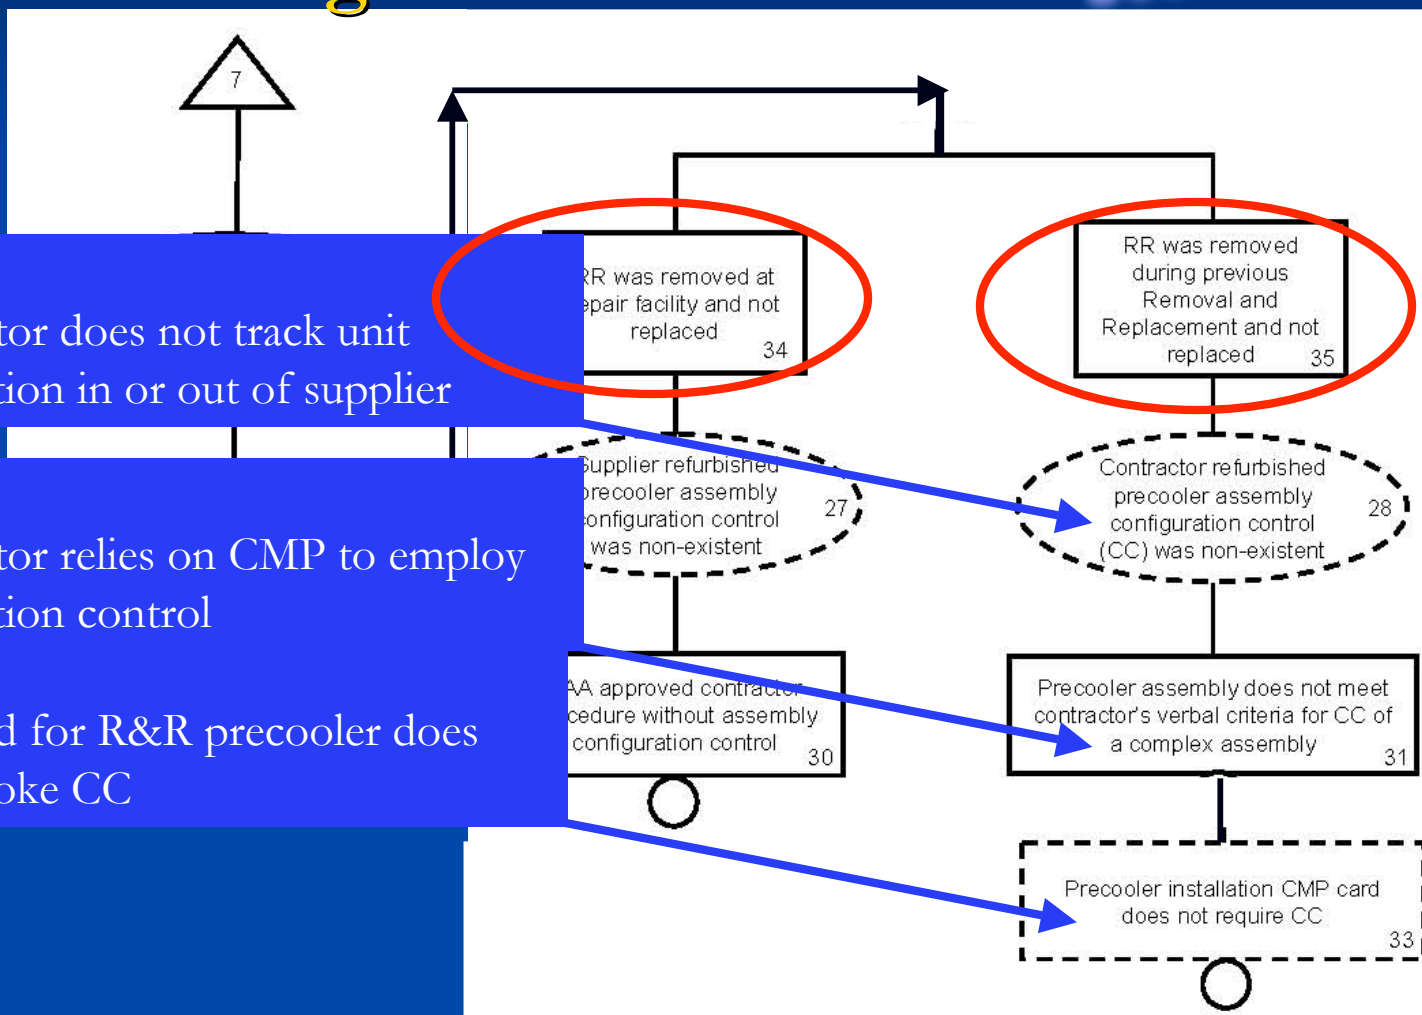
## RR Missing – Poor Config Control

- CMP card for R&R precoolers does not invoke CC

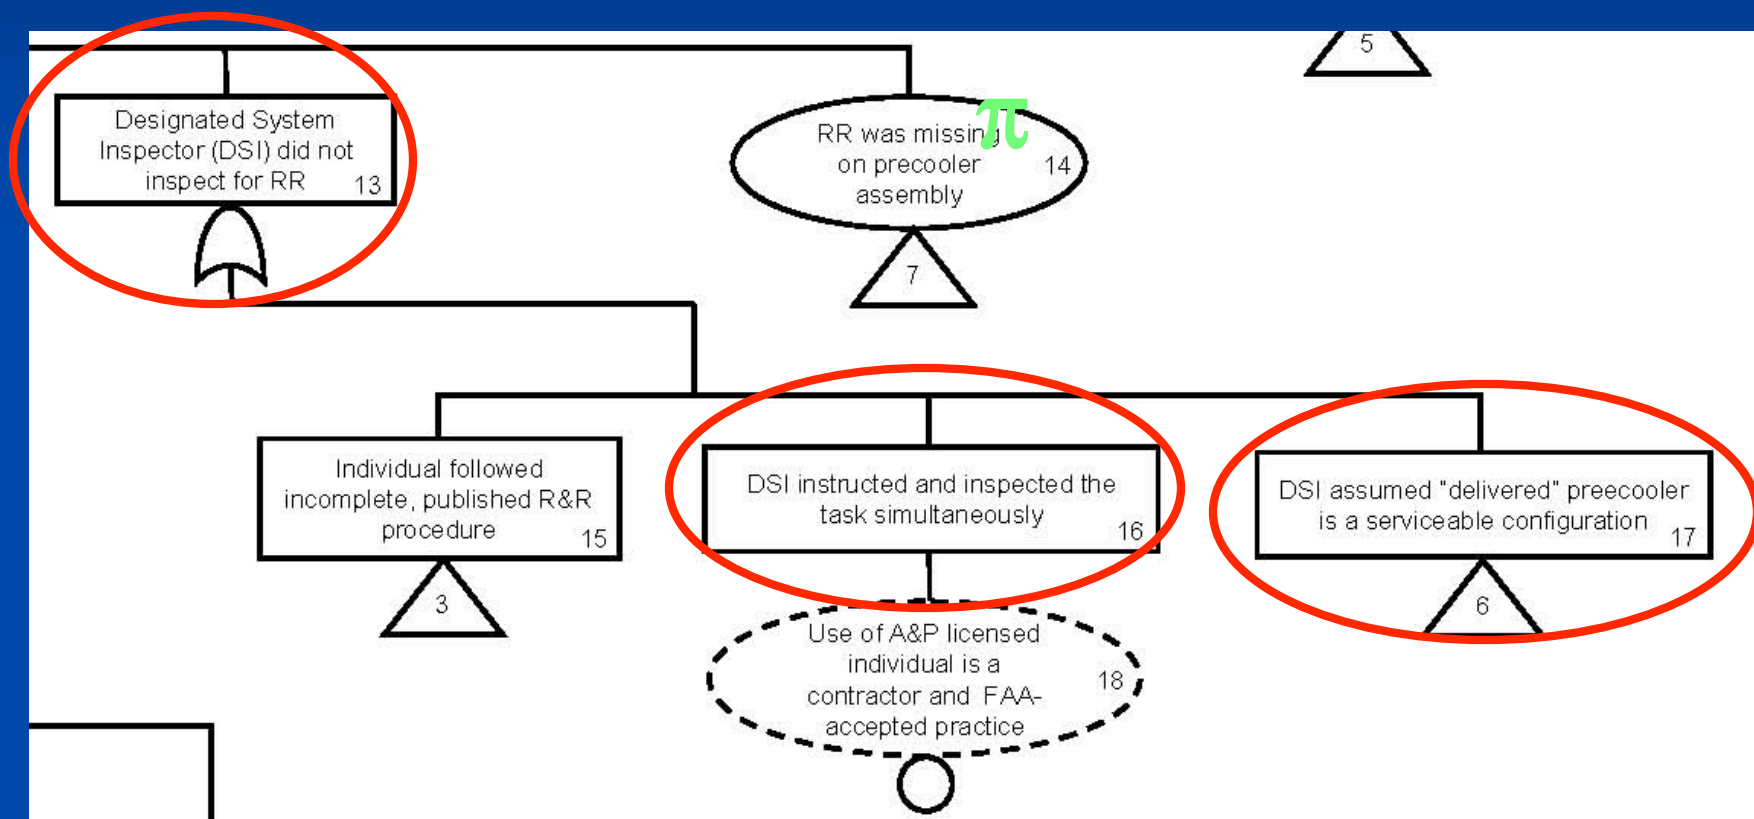
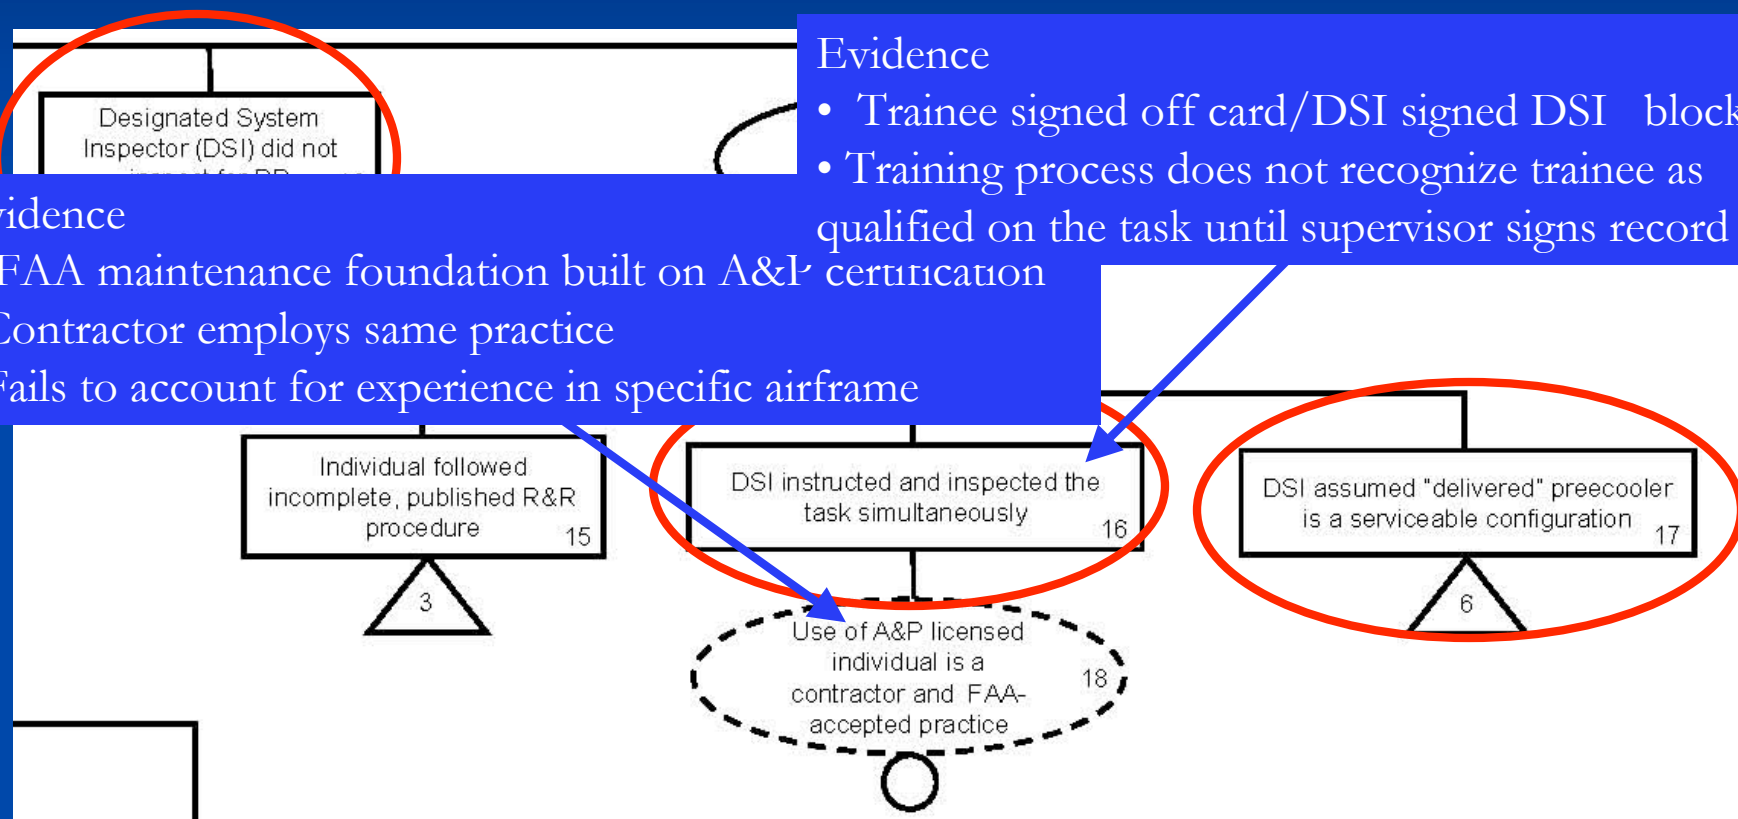
## DSI Did Not Inspect for RR

- FAA maintenance foundation built on A&P certification
- Contractor employs same practice
- Fails to account for experience in specific airframe

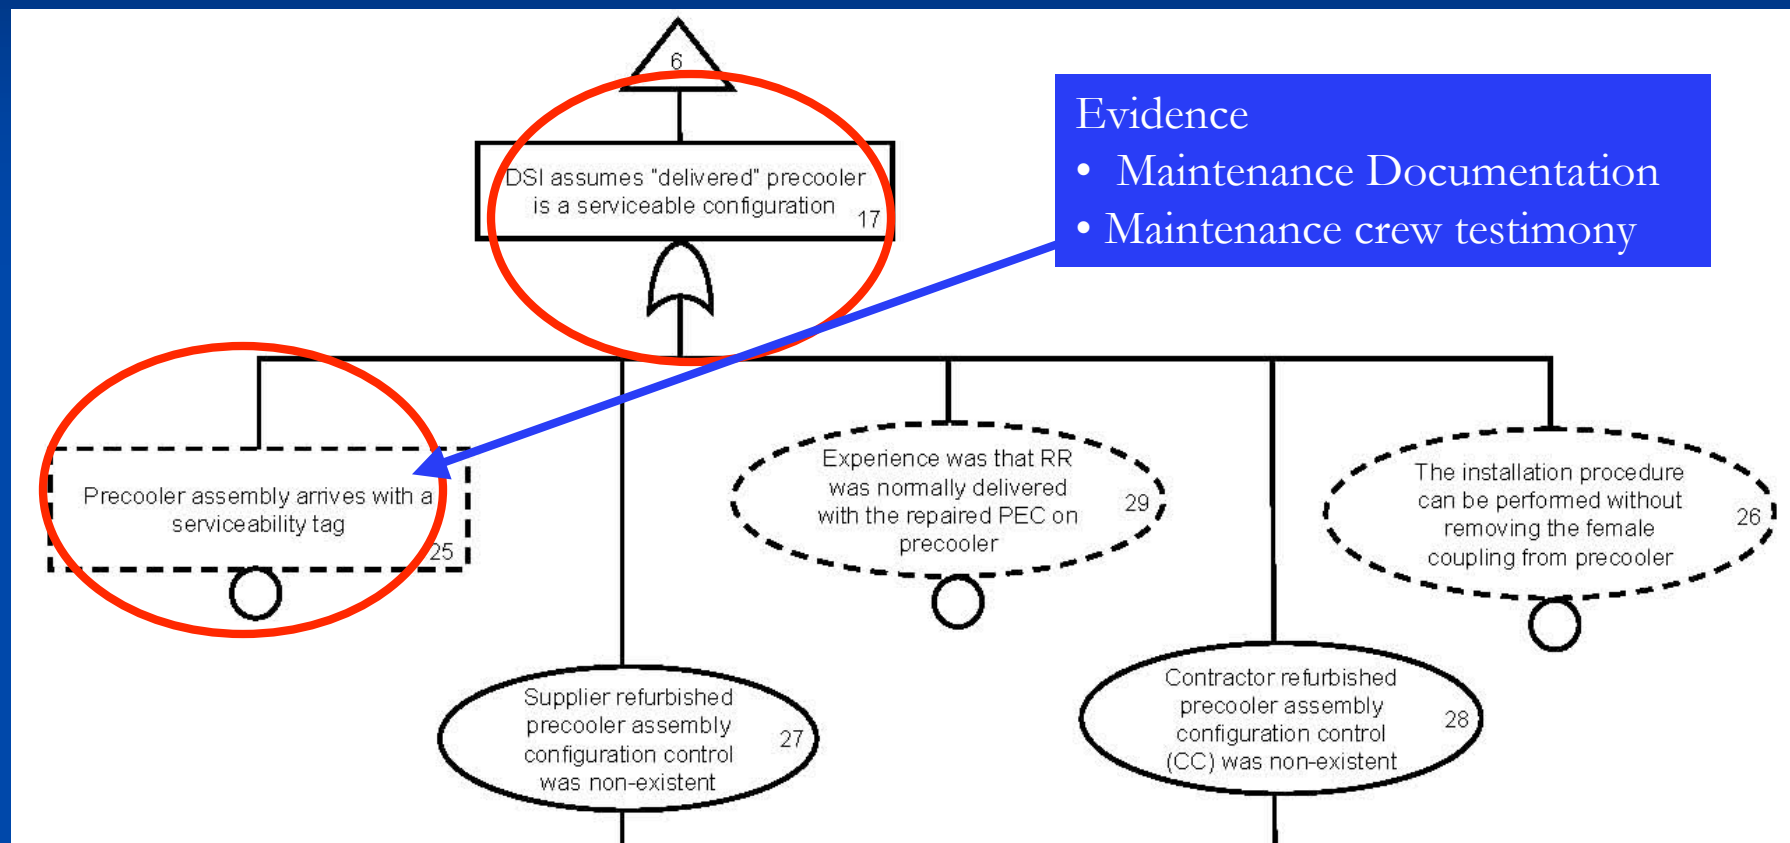
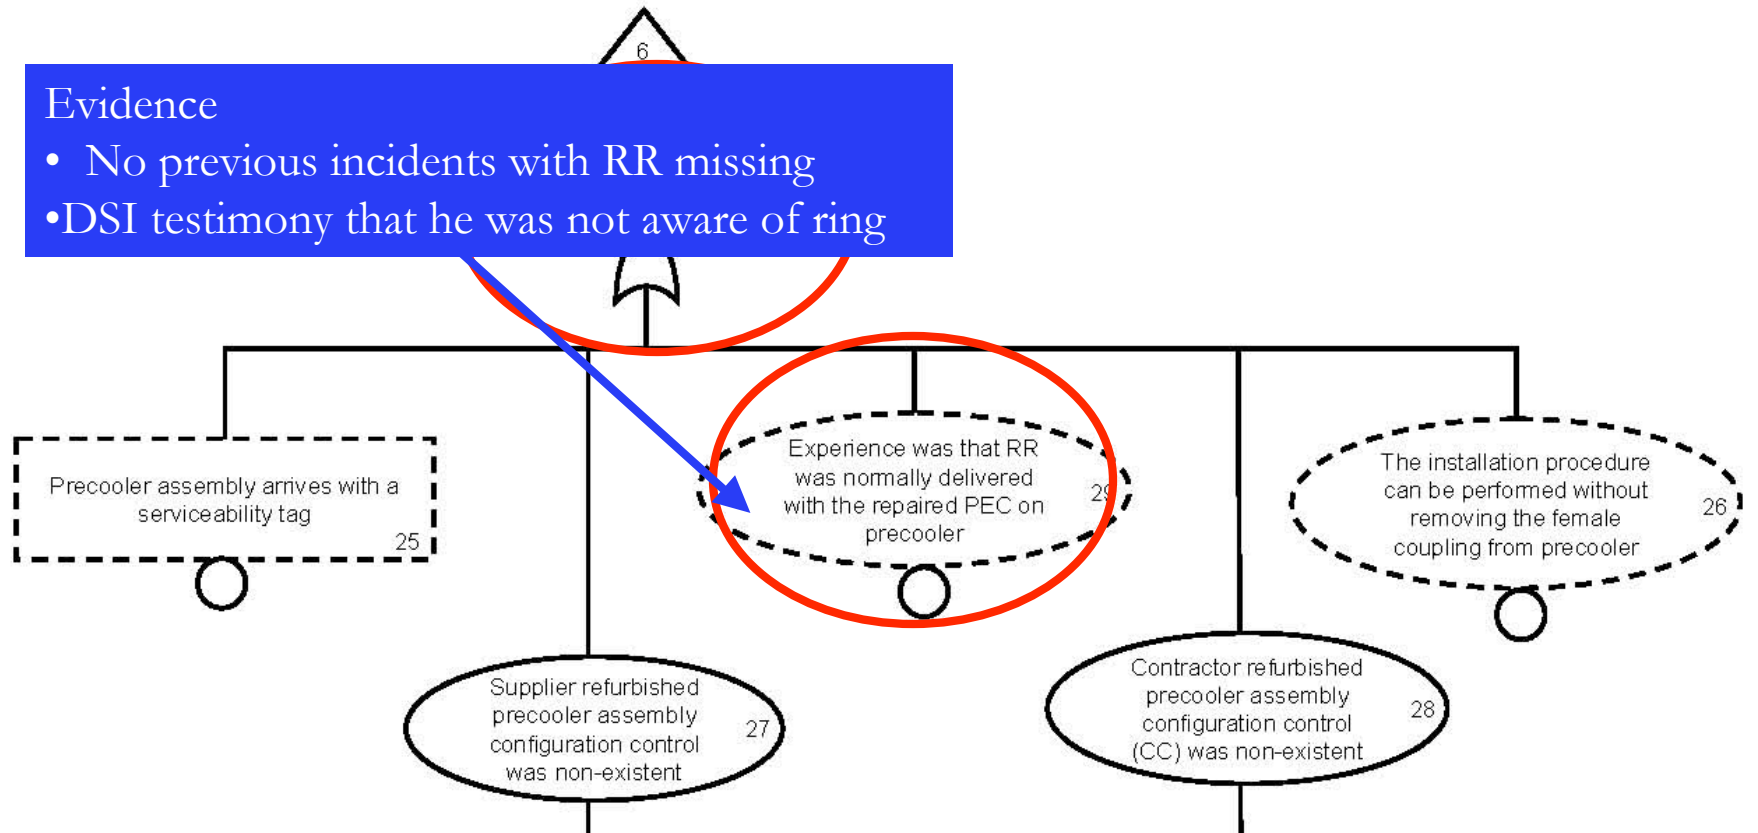
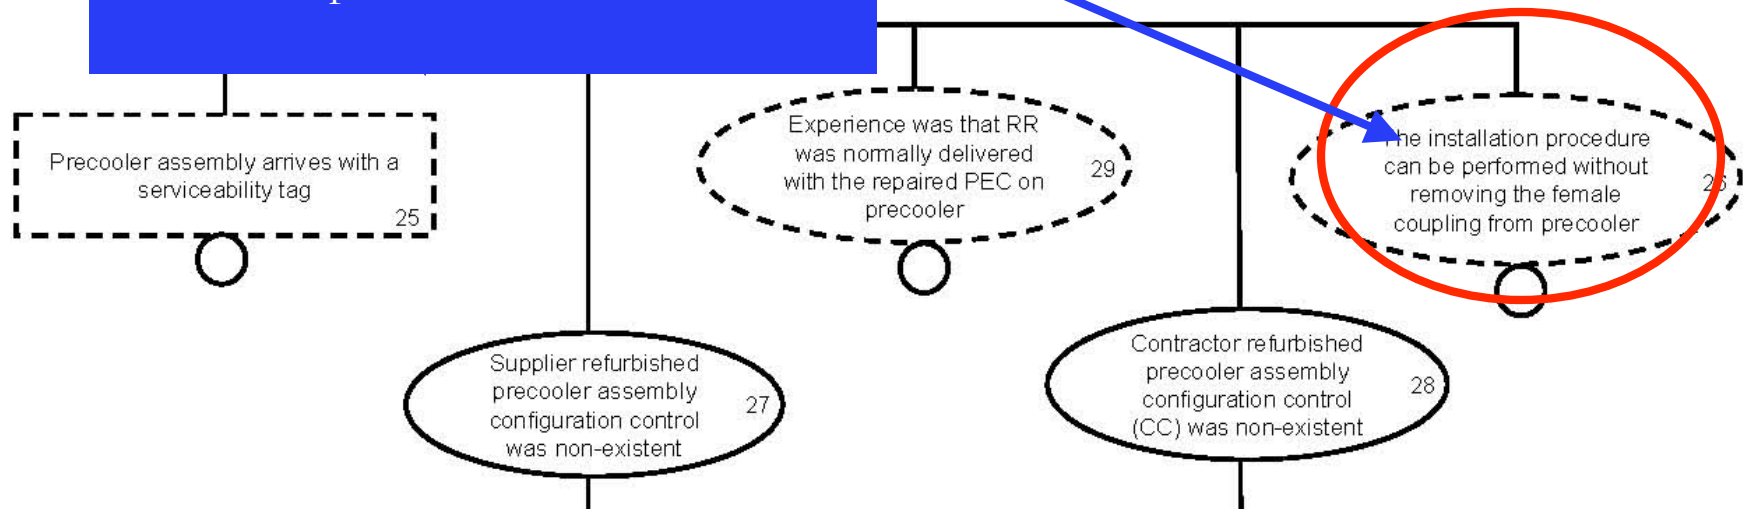
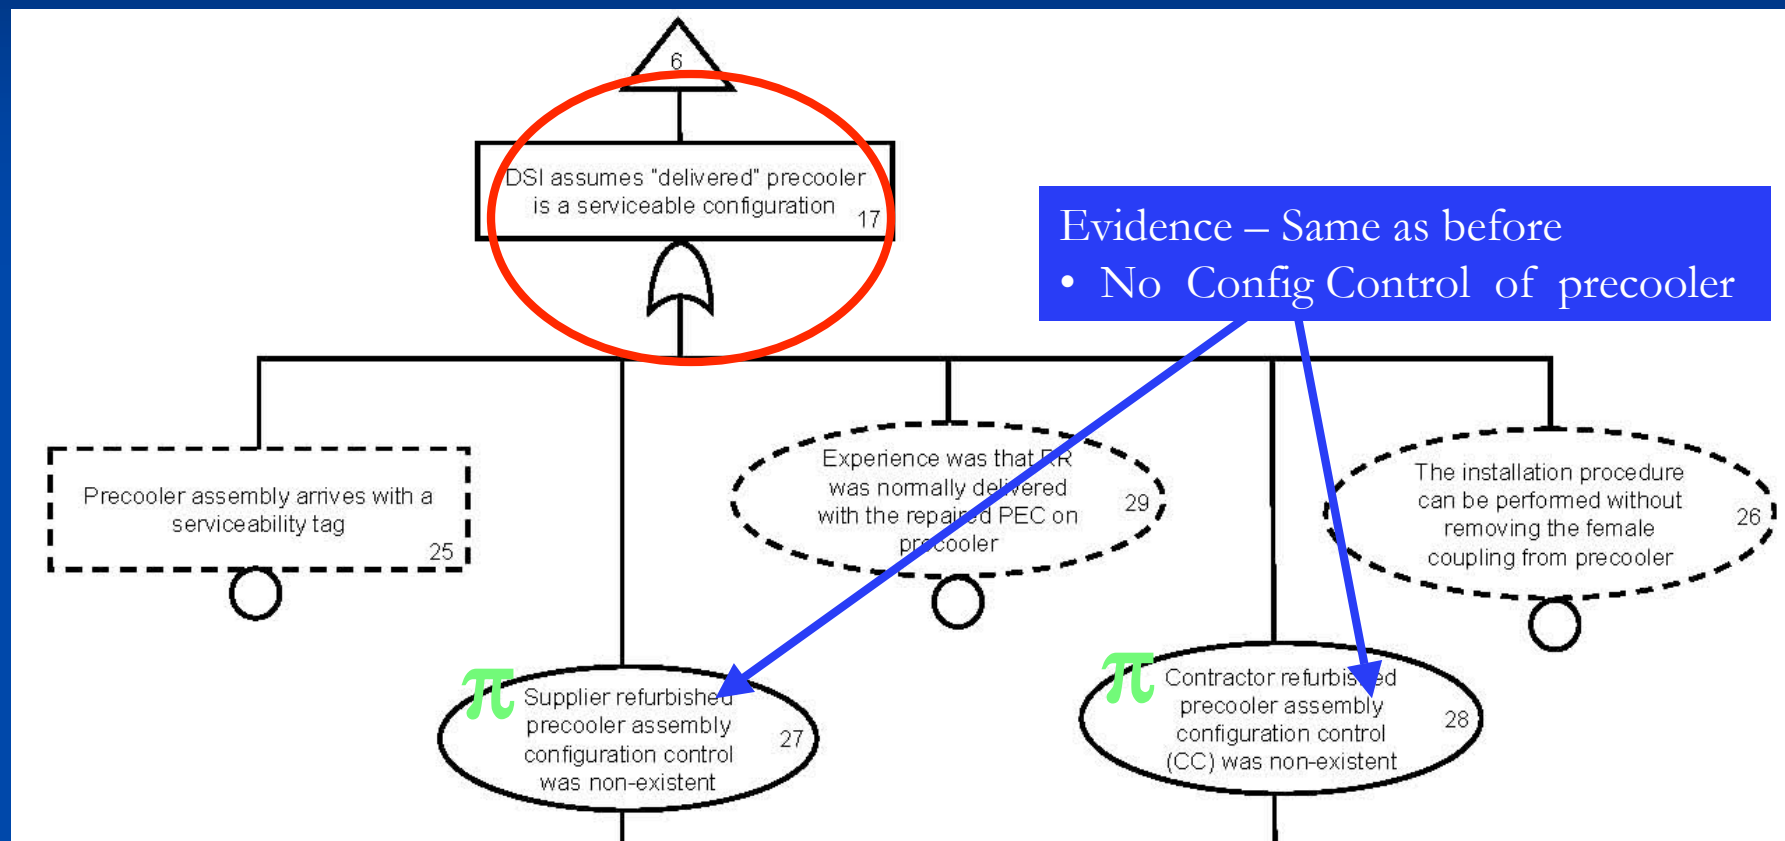
## DSI Assumes Serviceable Precooler

- No previous incidents with RR missing
- DSI testimony that he was not aware of ring

- O-rings can be installed without removing female portion of coupling
- Coupling halves join after precooler and duct in place

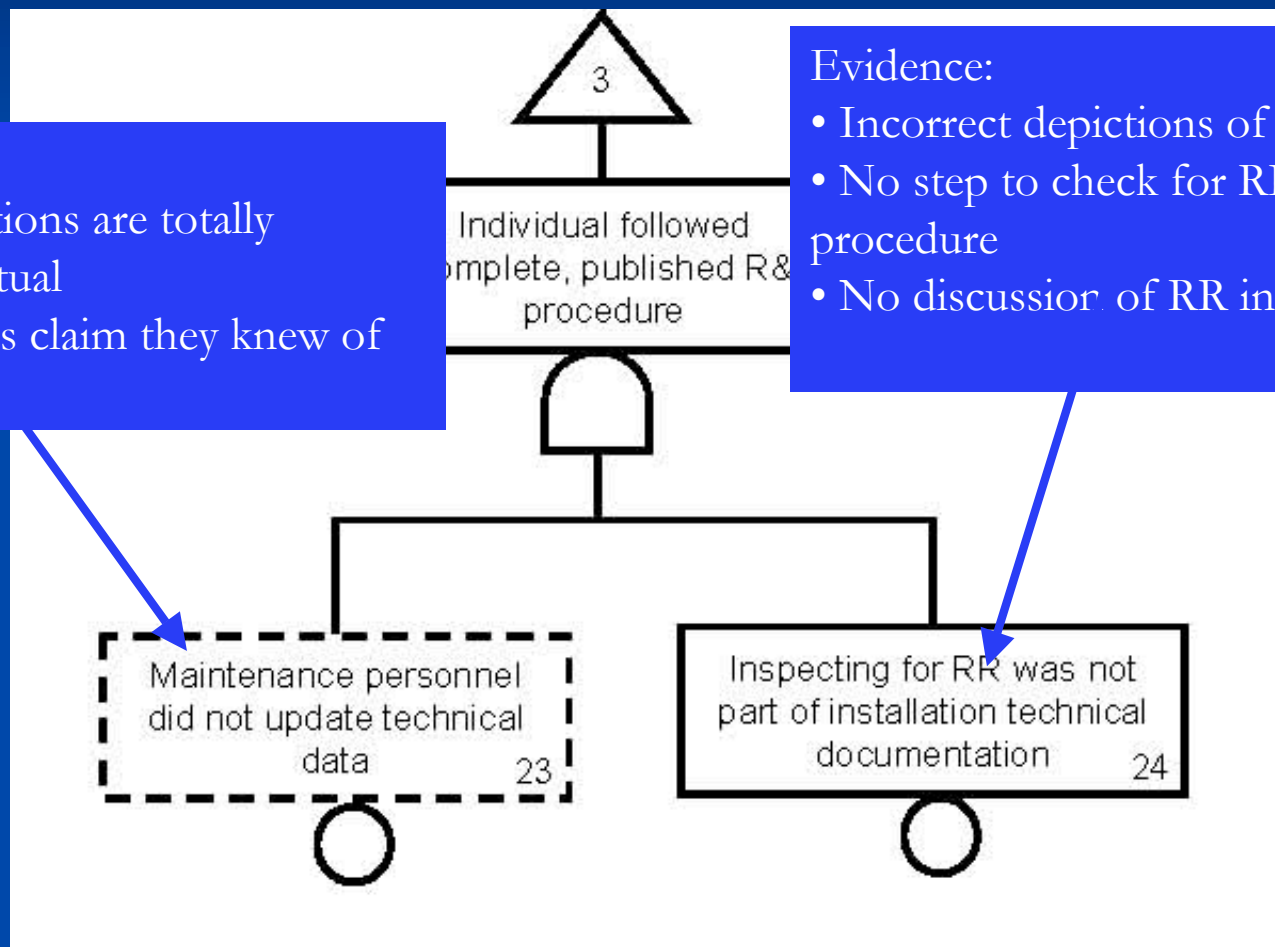
# Incomplete Precooler R&R Procedure

- Incorrect depictions of coupling
- No step to check for RR in CMP procedure
- No discussion of RR in IPC

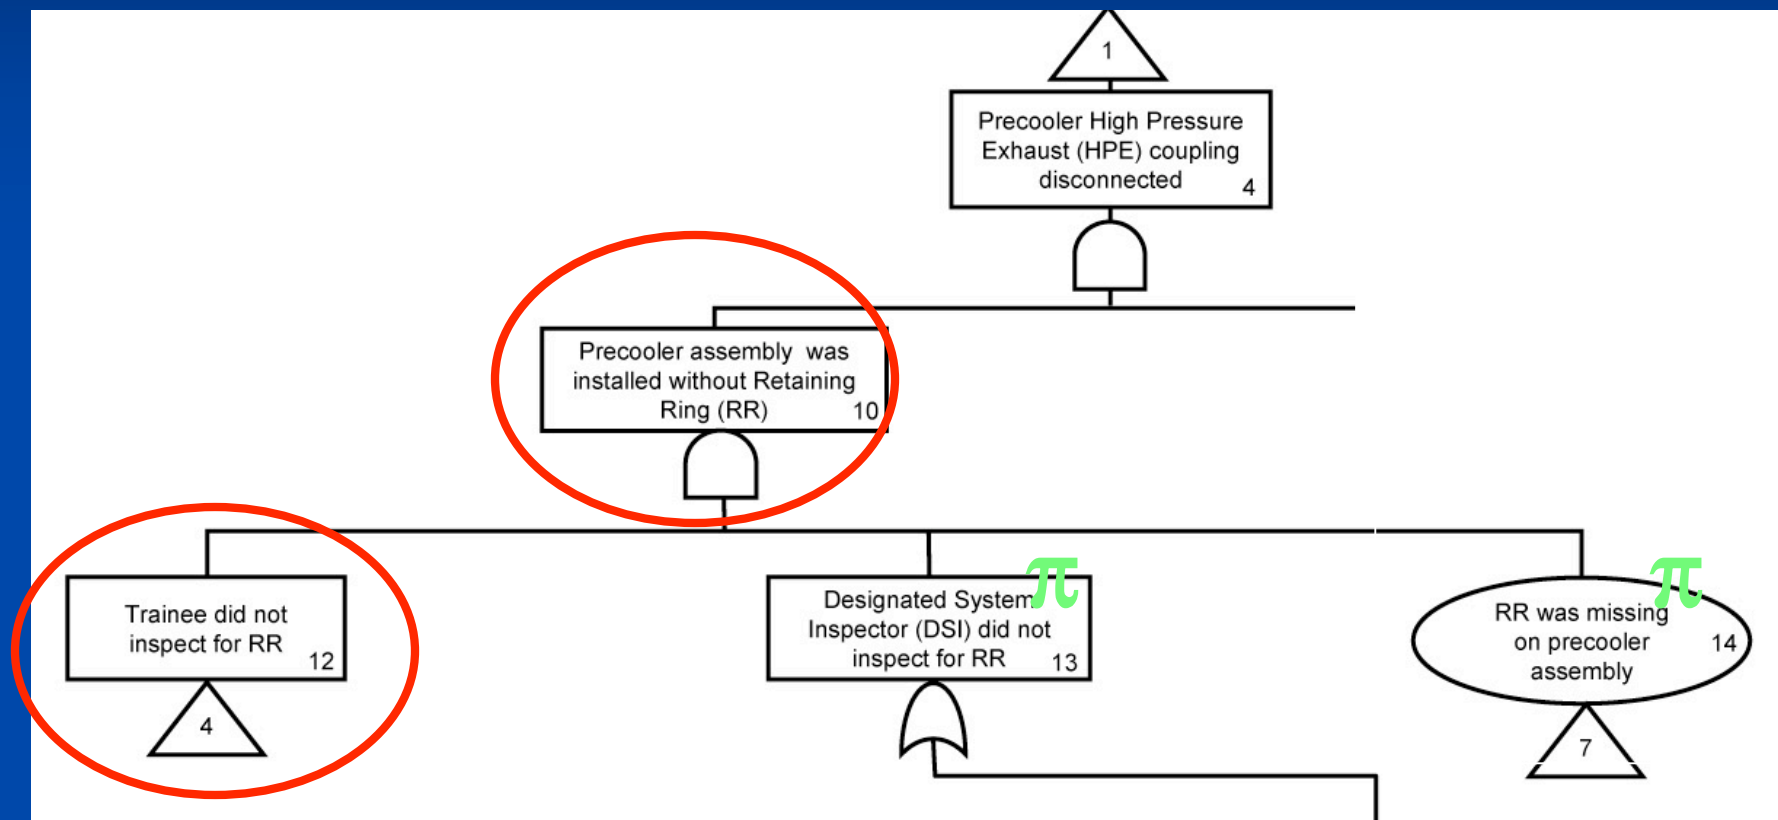
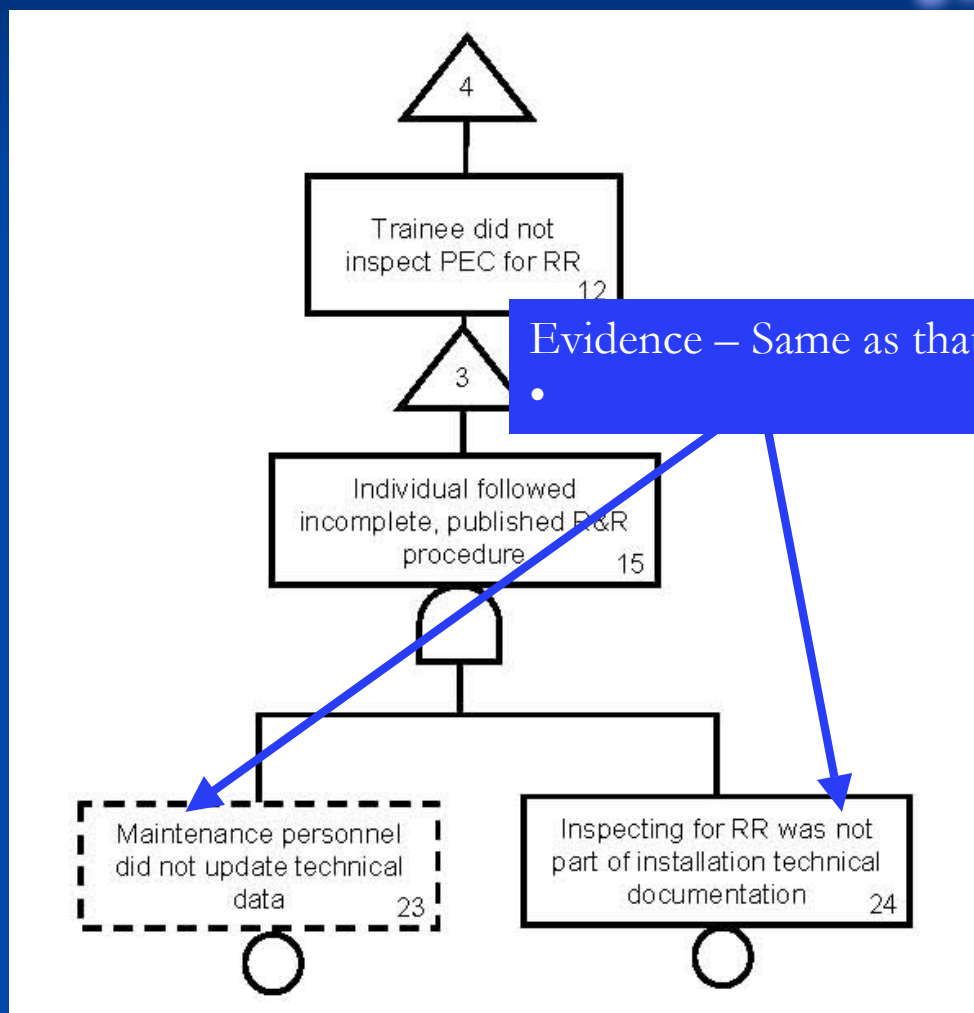
## Trainee Did Not Inspect for RR

Evidence – Same as that for the DSI
